Girley Bog Conservation Action Plan

Girley Bog NHA No.1580, Co. Meath, Ireland

2016-2020

Girley Bog NHA No.1580, Co. Meath, Ireland Conservation Action Plan 2016-2020

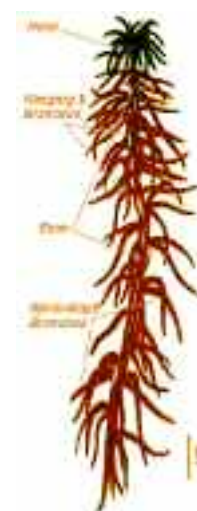
Sphagnum moss - the bog building plant

The *Sphagnum* plant's lower parts are dead and resistant to decay. Their remains can form peat as long as the habitat remains saturated. Some species form hummocks, others grow as carpets/lawns, while others grow in wet hollows. As *Sphagnum* hummocks grow upwards, the water table gradually rises over time, trapping more of the partly decayed plant remains in the stable lower layer and so forming peat. *Sphagnum* mosses store up to twenty times their own weight in water and help keep the bog surface saturated. Water is trapped around the outside of a plant with the help of hanging branches which are pressed close to the stem. The spreading branches interlock individual plants together which also helps to retain moist conditions all around. Internally there are large water storing hyaline cells which contribute to the wetness created by *Sphagnum* mosses at the bog surface. *Sphagnum* mosses are also very important at retaining acidic conditions on the bog surface. All of the water reaching the bog from rainfall is "filtered" for its nutrients. Any nutrients in the water are absorbed into the moss in an exchange process that involves pumping hydrogen out of the moss which acidifies bog water even further to pH levels of 4. *Sphagnum* mosses are "keystone species" on raised bogs producing an environment in which all other bog plants need to survive. That is why plant species numbers tend to be low on bogs because only specialist plants can survive the acidic, waterlogged environment created by *Sphagnum* moss plants. As all growth of *Sphagnum* moss takes place in the plant's tip, extending upwards, the plants are sensitive to grazing, trampling and burning. Five species are of particular importance for peat formation on raised bogs including: *Sphagnum austini*, *S. fuscum*, *S. papillosum*, *S. magellanicum* and *S. capillifolium*.

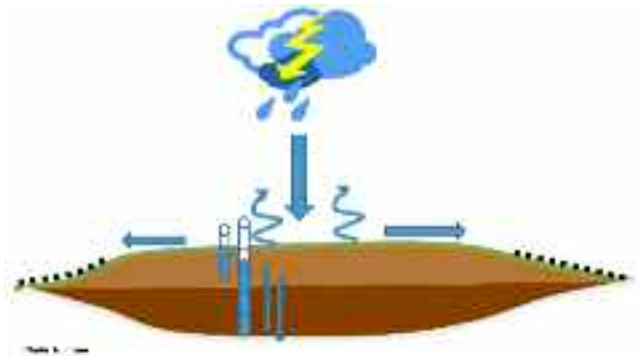
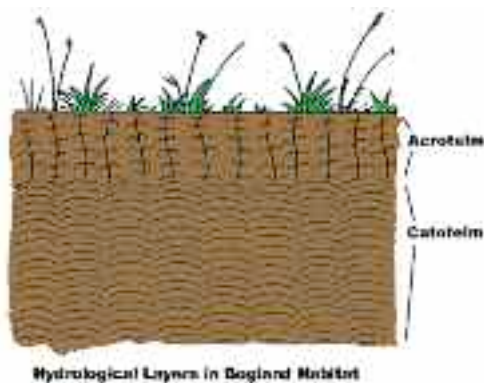
The diagram inset drawn by Dr Ray Flynn of Queens University in Belfast shows how water behaves in a raised bog.

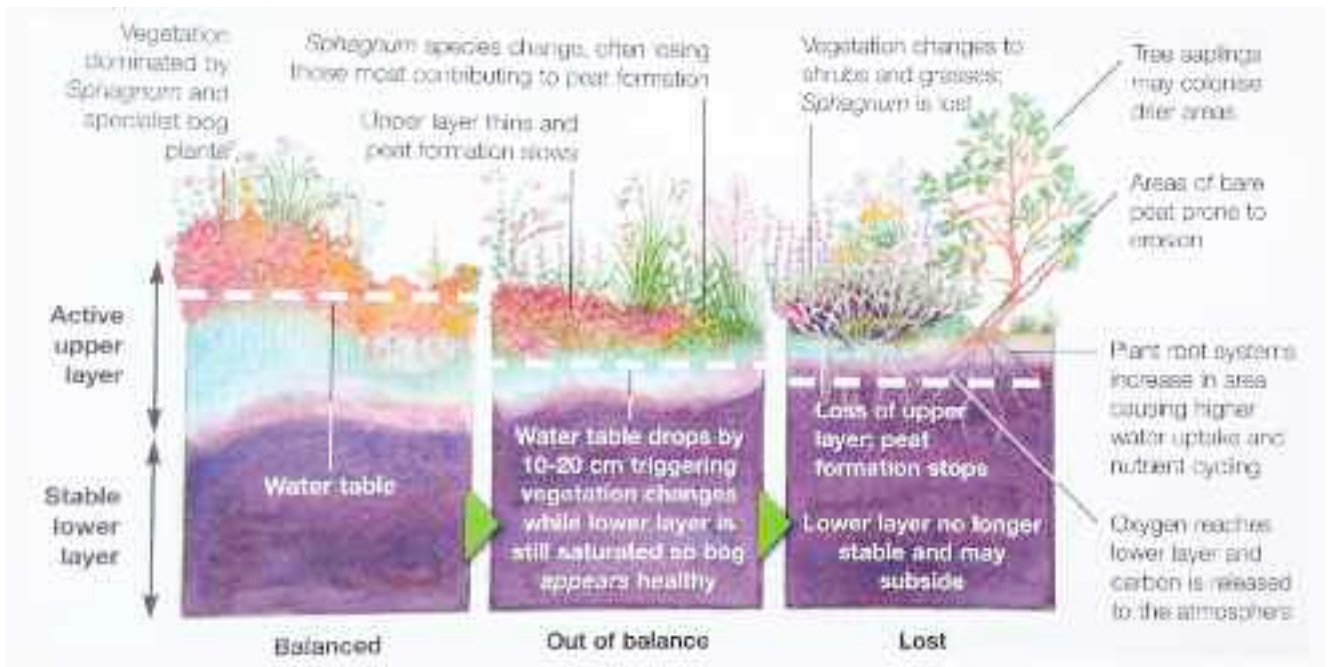
What happens to the vegetation on the bog surface when a bog is drained? Photo: O'Reilly et al 2012 adapted from a drawing by Richard Lindsay.

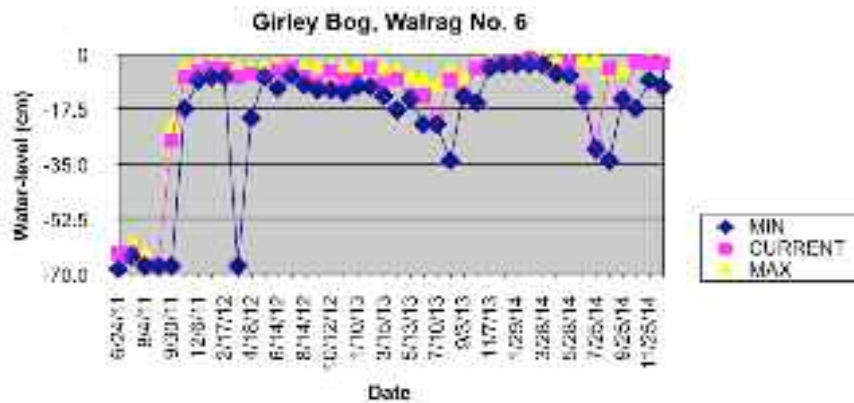
Hydrograph from Walrag No. 6 on Girley Bog. This water table measuring device was located within a closed canopy conifer woodland on the high bog. The conifers were clear-felled in August 2011 and the drains were blocked in 2013. Source: J. Derwin, Coillte

The conifer plantation on Girley Bog was clear felled in 2011. Waste material of no commercial value was wind-rowed on the site. Drains were blocked in 2013. Maximum and minimum water table levels in the plantation area were monitored before and after tree felling and following drain blocking via a series of six walrags.

The hydrograph below shows the dramatic increase in the water levels from 70cm below the surface to 10cm below the surface for walrag number 6 after tree removal and drain blocking.

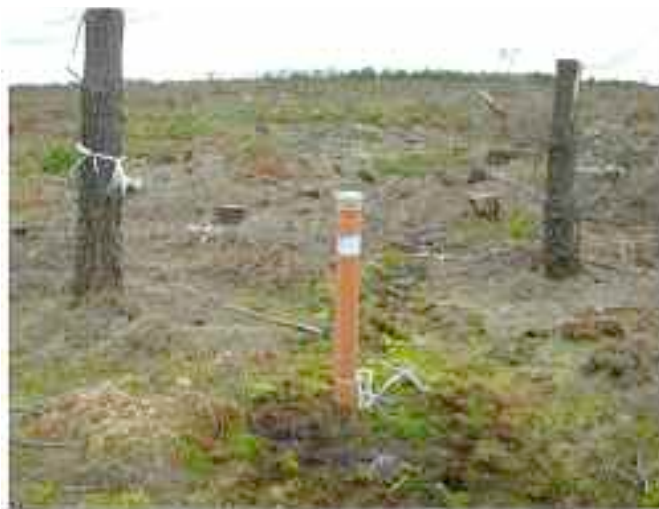
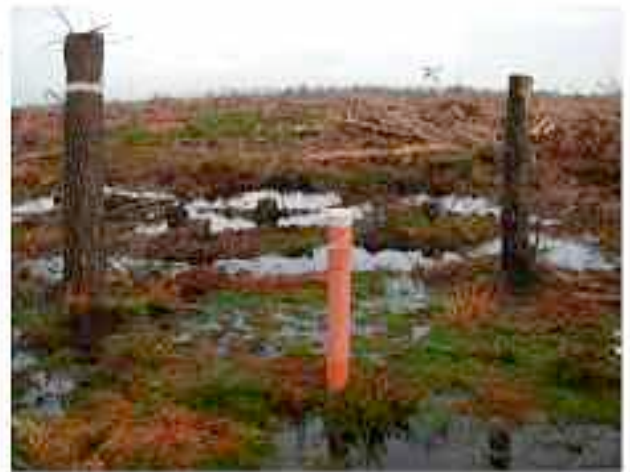
The location of Walrag No. 6 on Girley Bog in Co. Meath. The forest was clear-felled in August 2011. The image on the left was photographed in July 2012 and the one on the right was photographed in January 2014. The dramatic increase in water levels can be seen. Photo: J. Derwin, Coillte

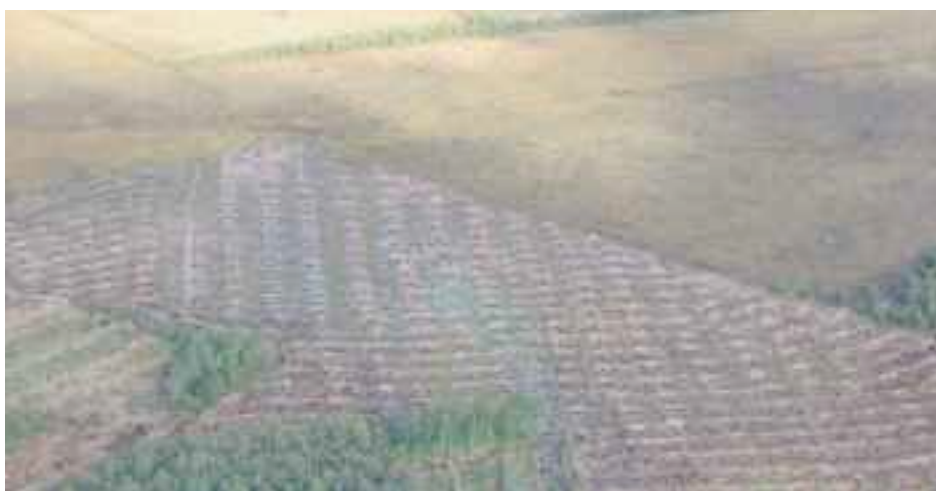
Air photograph taken in October 2013 showing the former Coillte forested area of the high bog, the wind rowed waste wood material and the water pooling on the bog surface due to the effect of drain blocking. Photo: Coillte/NPWS the drains have been blocked.

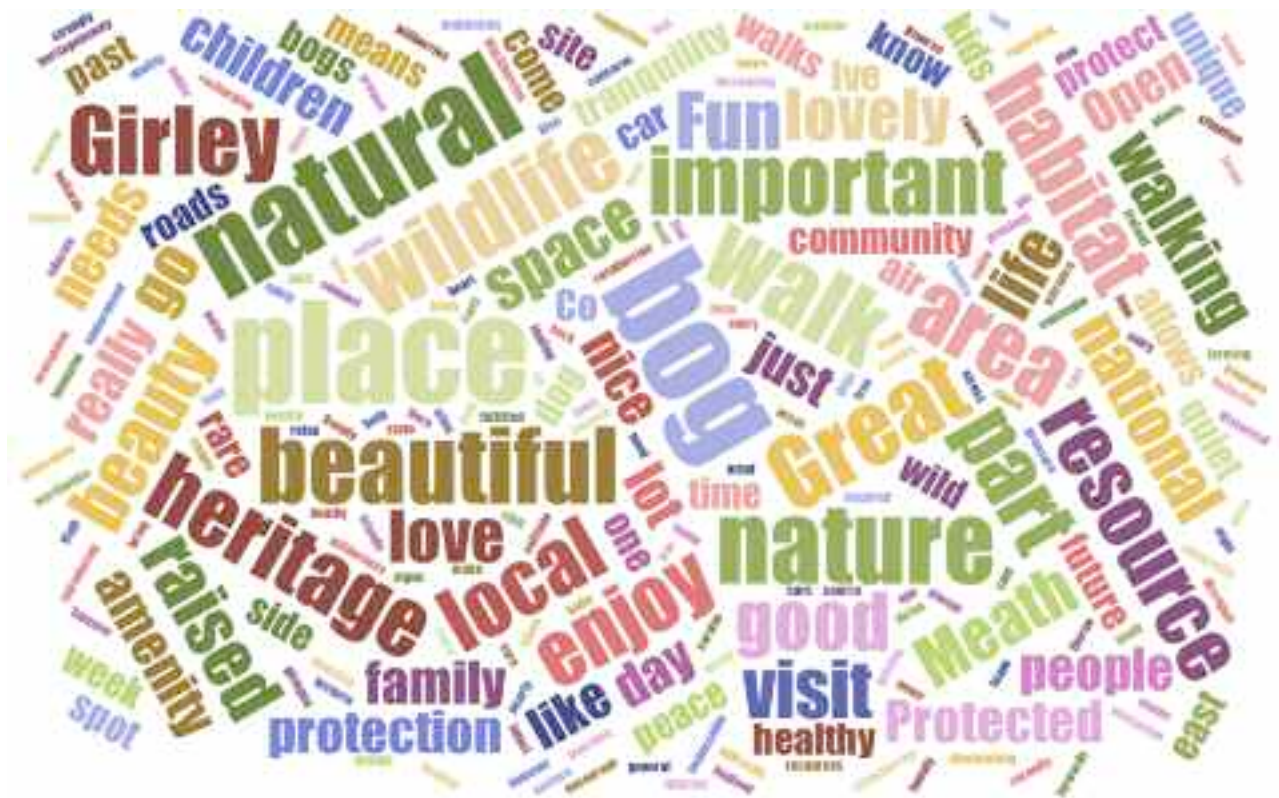
This was our first open-ended question where respondants could write a couple of words, a sentence, or a paragraph to outline their own experience of the bog and how they personally felt about same. In order to analysis this each answer was taken and inserted into a word cloud generator. Effectively this leads to a highlighting of the words which are being used repetitively in answers and brings common themes to the fore. The major themes which were found to emerge from this question were the idea of nature and a wilderness high-

lighting that an unspoiled natural landscape is what people enjoy when visiting the loop walk. This in turn indicates that the driver behind the management plan should be to make and retain the entire site as a natural and relatively untouched environment.

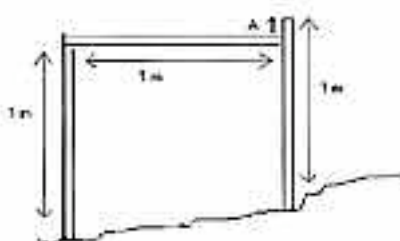
Height levelling of a peatland surface. The length of A indicates the distance the surface rises or falls over 1m.
